SERVICE NEWS LETTER 058 (Rev.)

DATE: JULY 10, 2001

MES50 TRANSMISSION BELL HOUSING WATER ENTRY

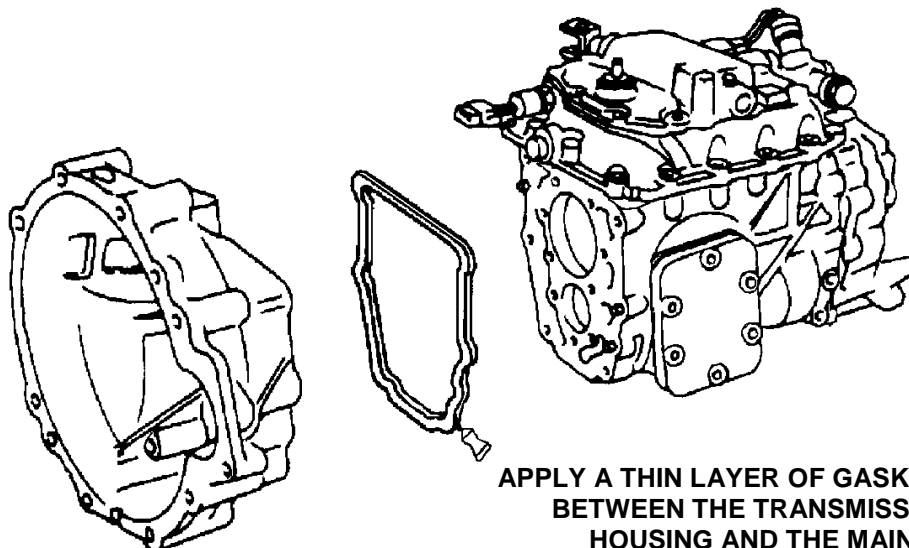
Field investigation has determined that rainwater entry may occur due to poor sealing between the transmission bell housing and the main case of unsold UD1200 and UD1400 model vehicles in long-term storage without a rear body.

3. Remove the transmission bell housing from the main case as shown below and apply a layer of sealer between bell housing and the transmission main case. The recommended sealer is UD Genuine Part Number 10121-90225 or a suitable equivalent such as Loctite World Tech # 599.
