NISSAN DIESEL AMERICA, INC.

RECALL BULLETIN O3V-224

**VOLUNTARY SAFETY RECALL CAMPAIGN NUMBER O3V-224:
 INSPECT AND REPLACE PASSENGER SEAT BELT ANCHOR ON
 2002 ~ 2004 MODEL YEAR UD1200/UDI400/UDI800CS VEHICLES**

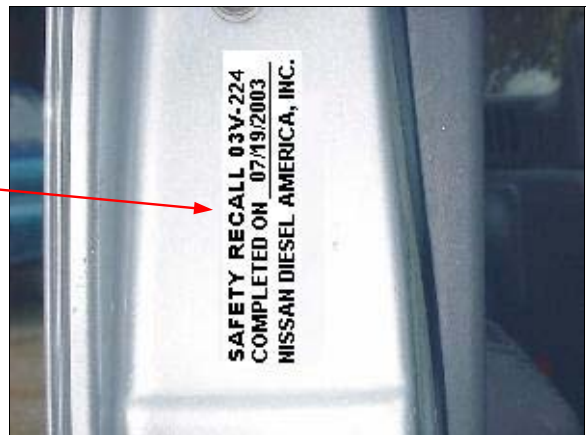
THIS STICKER INDICATES THAT THE SAFETY RECALL HAS ALREADY BEEN PERFORMED.

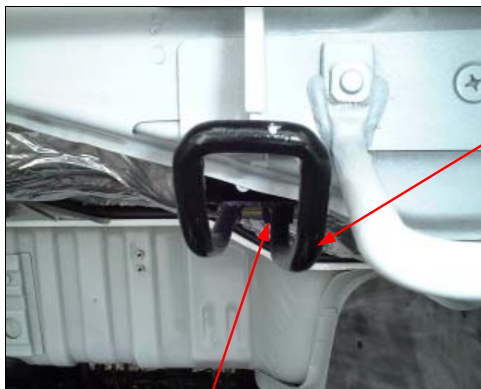
NOT NECESSARY TO REPLACE SEAT FRAME

- Check the passenger seat belt anchor from the back of the cab.
 - If the anchor resembles the photo on the left, no further action is necessary. Proceed to Step 9 on Page 5 of this bulletin.
 - If the anchor resembles the photo on the right, the passenger seat frame must be replaced. Proceed immediately with the instructions on the following page.

OUTSIDE LOWER THAN INSIDE

SEAT BELT ANCHOR BOLT OUTBOARD

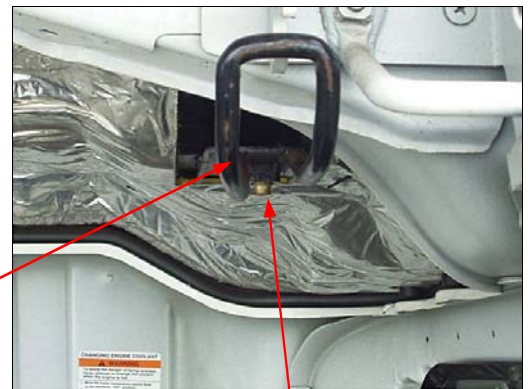
SEAT FRAME MUST BE REPLACED

The possibility exists that the passenger seat belt installed on the involved vehicles may have the incorrect seat belt anchor welded to the seat frame. The installation of the incorrect passenger seat belt anchor was the result of an assembly procedure change during the manufacturing process. The incorrect seat belt anchor may not adequately restrain the passenger seat in the event of a collision and may result in an increased risk of injury to the passenger.

INSIDE LOWER THAN OUTSIDE

SEAT BELT ANCHOR BOLT IN THE MIDDLE

The repairs to correct this condition consist of inspecting the passenger seat belt anchor, removing the affected seat frames and installing replacement seat frames.

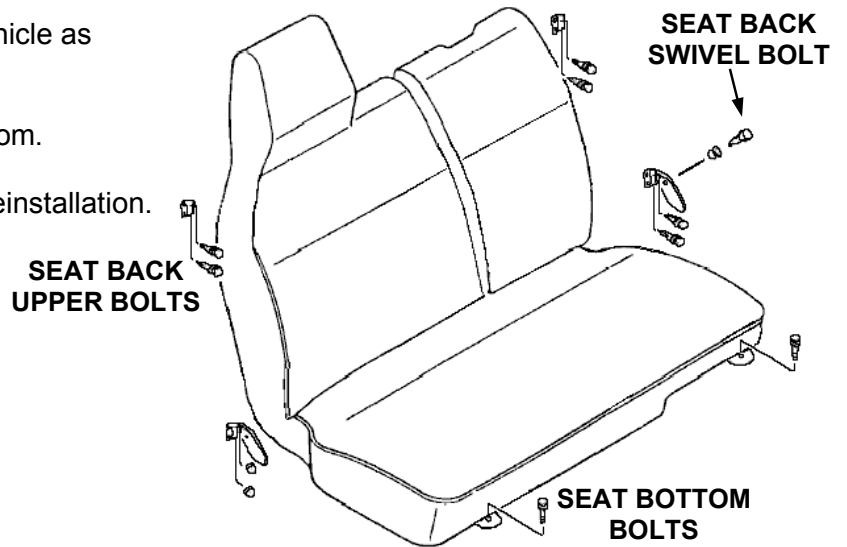
1. Remove the passenger seat from the vehicle as shown.

- Separate the seat back from the seat bottom.
- Save the seat back and all fasteners for reinstallation.

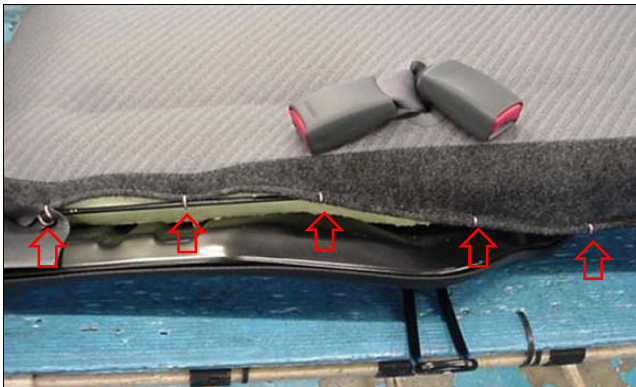
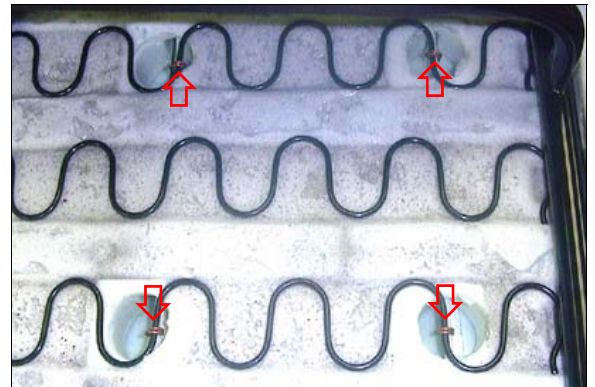
2. Remove all clips attaching the seat cover and cushion to the seat bottom frame. Remove the seat cover and cushion and save both for reinstallation.

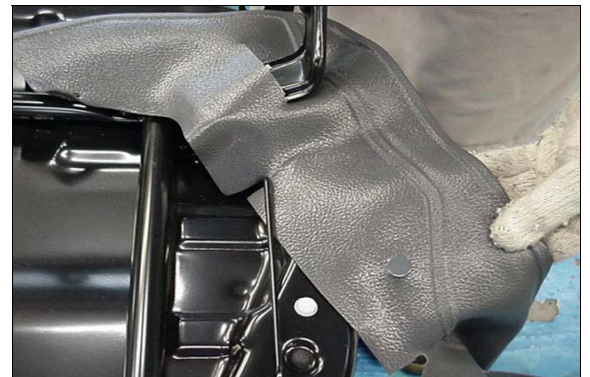
3. Remove the trim skirt and save for reinstallation.

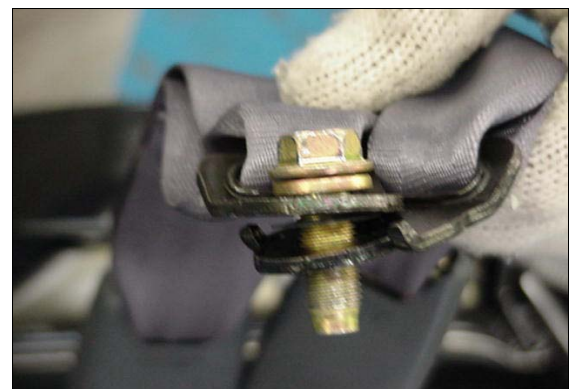
4. Remove the seat belt buckle assembly from the frame.

- Do not separate the bolt from the seat belt buckle assembly.
- Save the seat belt buckle assembly and bolt for reinstallation.
- Discard the seat frame.

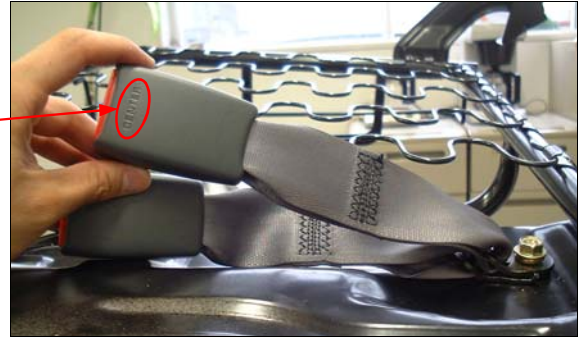
5. Obtain a replacement passenger seat frame, part number 7420029D00. Attach the seat belt to the seat frame.

- Ensure that the center seat belt buckle (identified by the word "CENTER" on the buckle) is positioned on top. The passenger seat belt buckle is positioned on the bottom.
- Tighten the seat belt bolt to 44 ~ 55 N•m (32.5 ~ 39.8 ft•lbs) of torque.

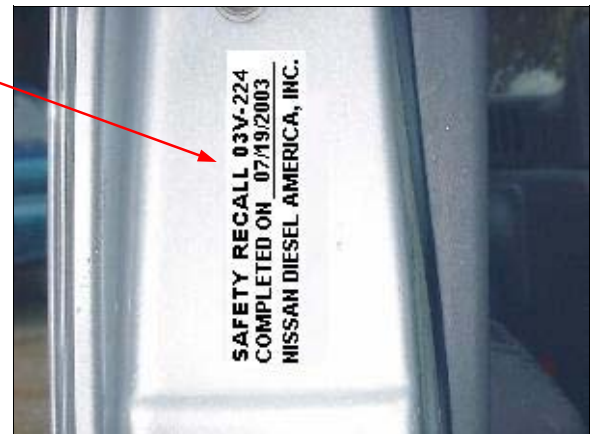
9. Record the completion date on the Safety Recall 03V-224 sticker and apply it to the driver's side door as shown.
